Name Of Dam: WINDSOR LAKE
Location: CITY OF ROANOKE
Inventory Number: VA 77001

PHASE I INSPECTION REPORT NATIONAL DAM SAFETY PROGRAM

NOVEMBER 1980

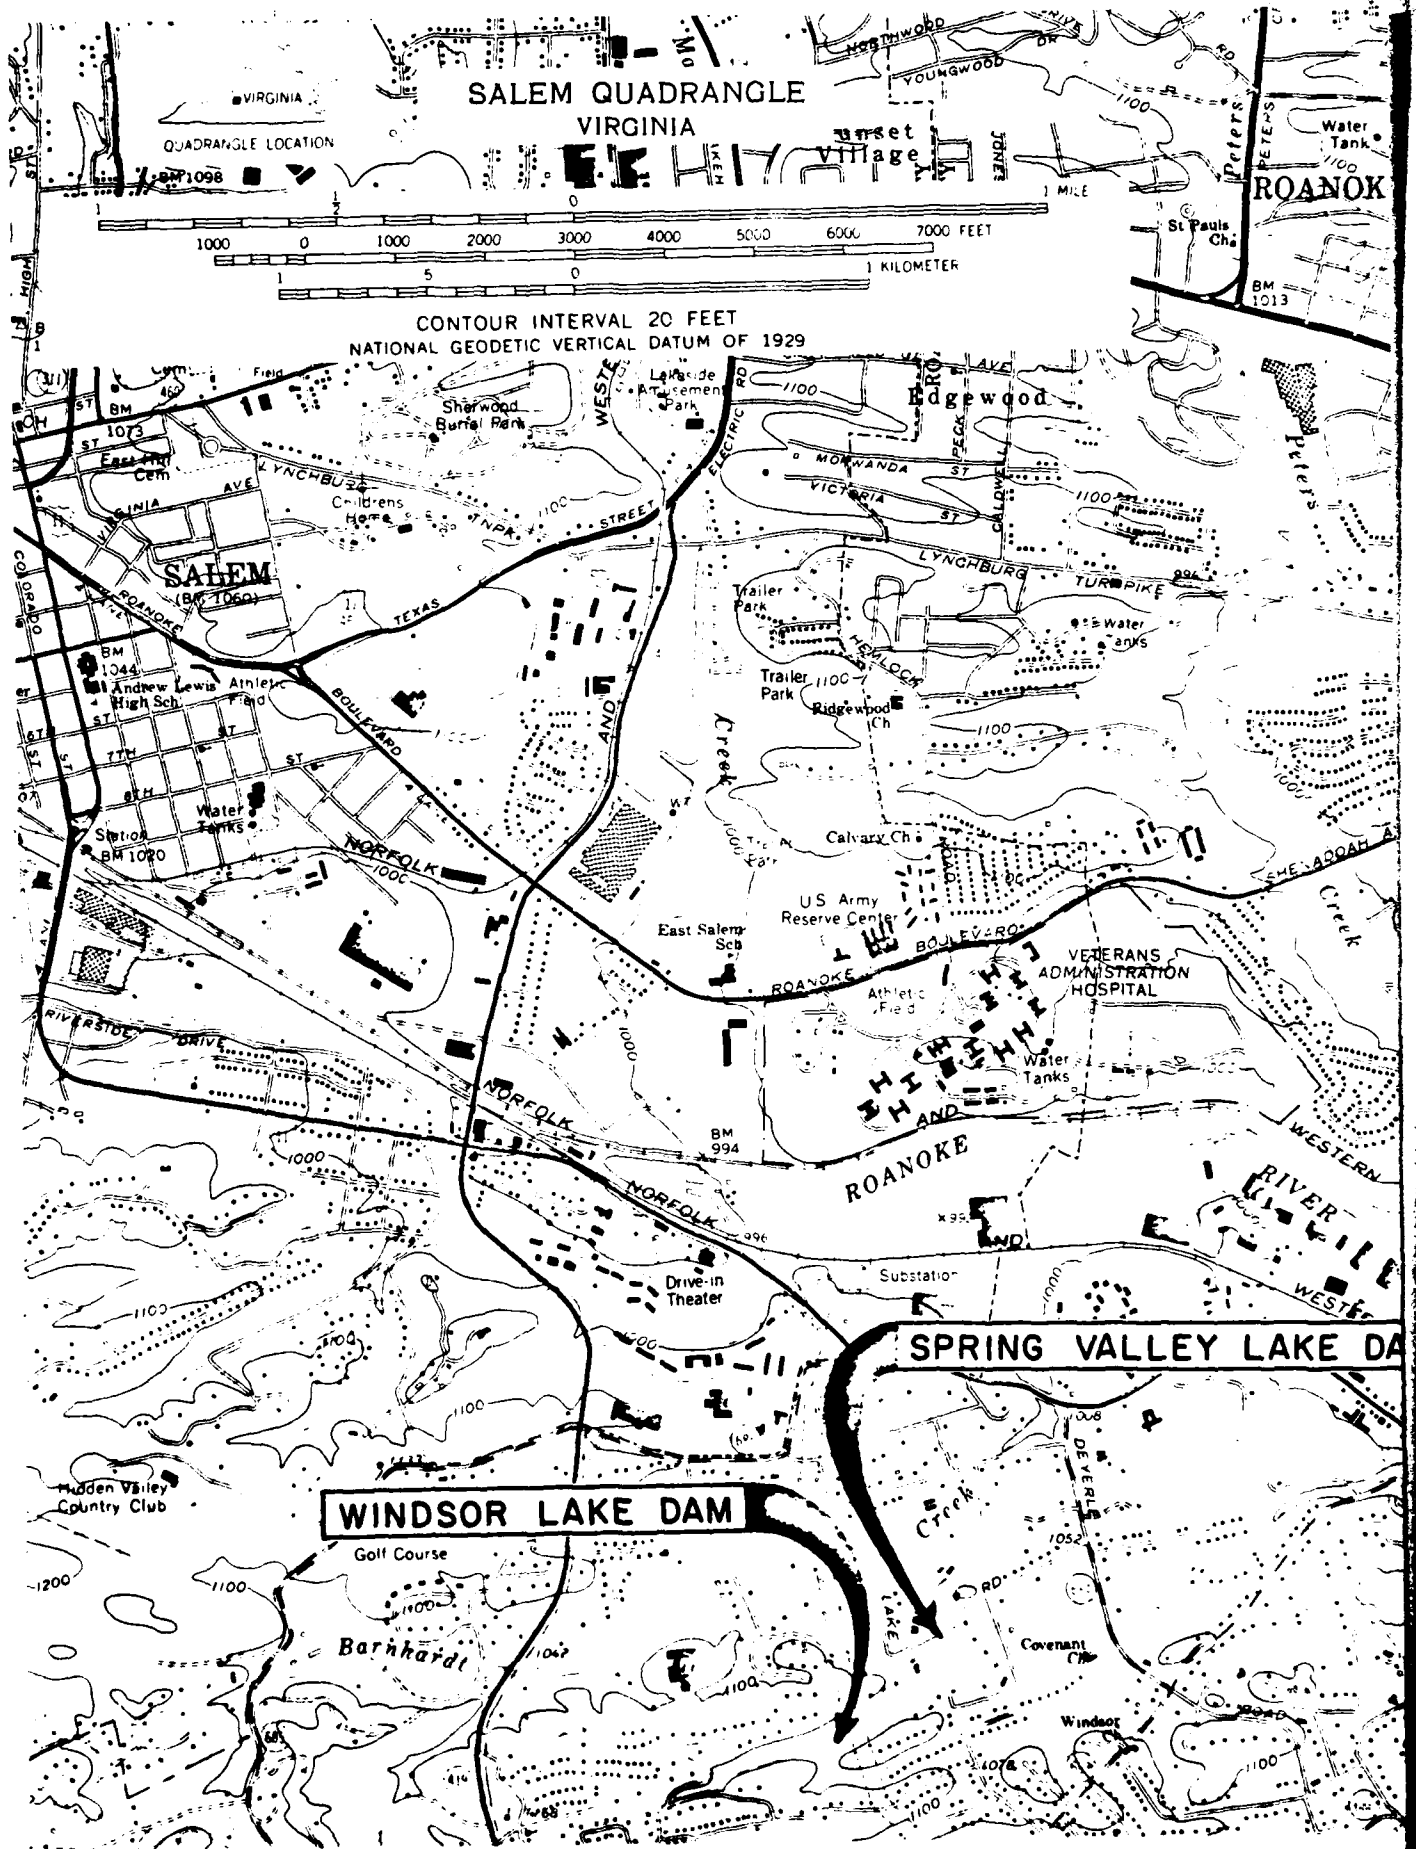
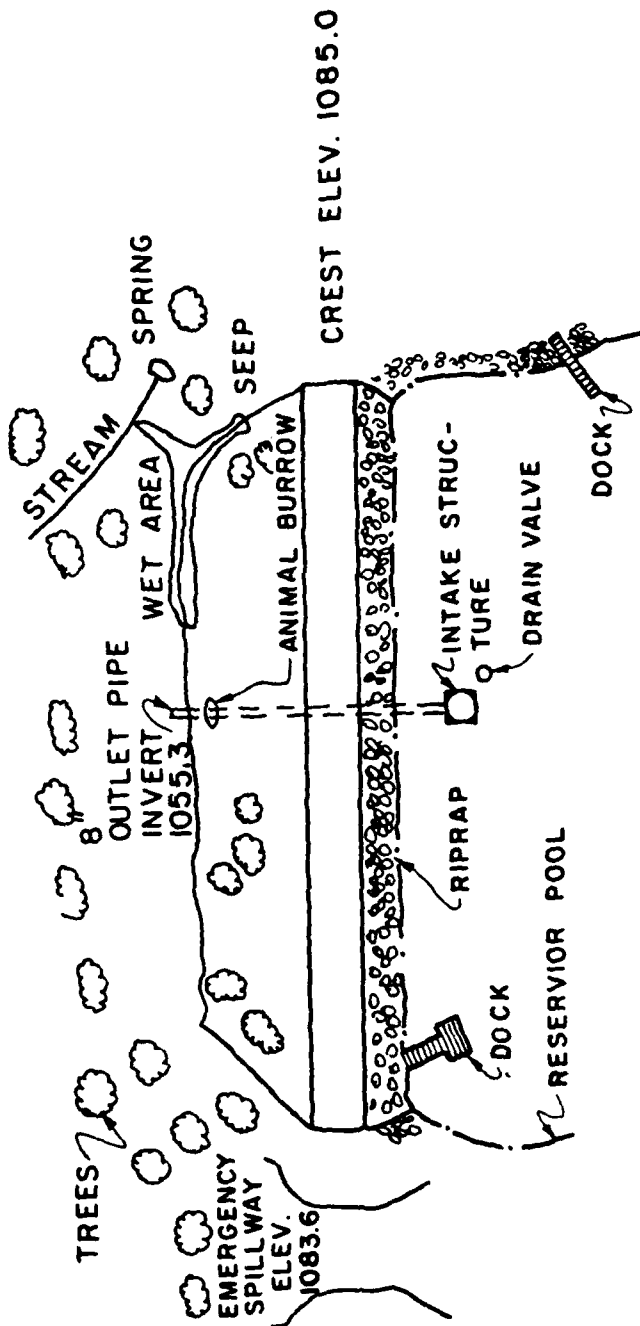
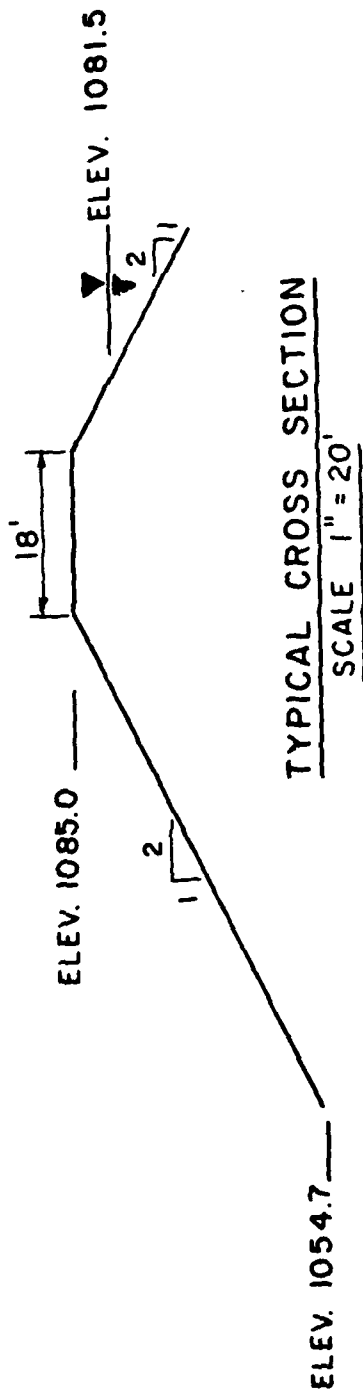
PLAN VIEW OF THE DAM
NOT TO SCALE

There are no signs of surface cracks, unusual movement, sloughing, misalignment, or riprap failures. However, there are several bare spots located on the crest approximately 50 feet right of the left abutment. Also, a small hole about 8 inches in diameter is located on the upstream face just above the principal spillway outlet pipe. (See Plate II, Appendix I).

A wet area is located along the downstream toe. It extends from the right abutment approximately 30 feet towards the principal spillway outlet pipe. Cattails and reeds are growing in this area. (See Plate II, Appendix I).

A seep is located on the downstream right abutment at elevation 1065.2. Its flow runs down the abutment saturating the toe, and continues downstream. The flow is clear but the rate was not measured. (See Plate II, Appendix I).

- a. The bare spots on the crest should be regraded and reseeded.
- b. The small hole above the principal spillway outlet pipe should be backfilled with compacted material and seeded.
- c. The wet area along the toe, the spring in downstream right abutment area, and flow from the principal spillway outlet pipe should be monitored for an increase in flow during periodic inspection and after higher pool levels in the reservoir. The seeps should be monitored for increased flow.
- d. The small shrubs on the face of the dam should be cut off at their roots.
